**Pipeline Group Factual Report**

**Kiefner ERW Pipe HCA-Related Integrity Assessments**

**Carmichael, Mississippi  
DCA 08 MP 001**

**DEALING WITH LOW-FREQUENCY-WELDED ERW PIPE AND FLASH-  
WELDED PIPE WITH RESPECT TO HCA-RELATED INTEGRITY ASSESSMENTS**

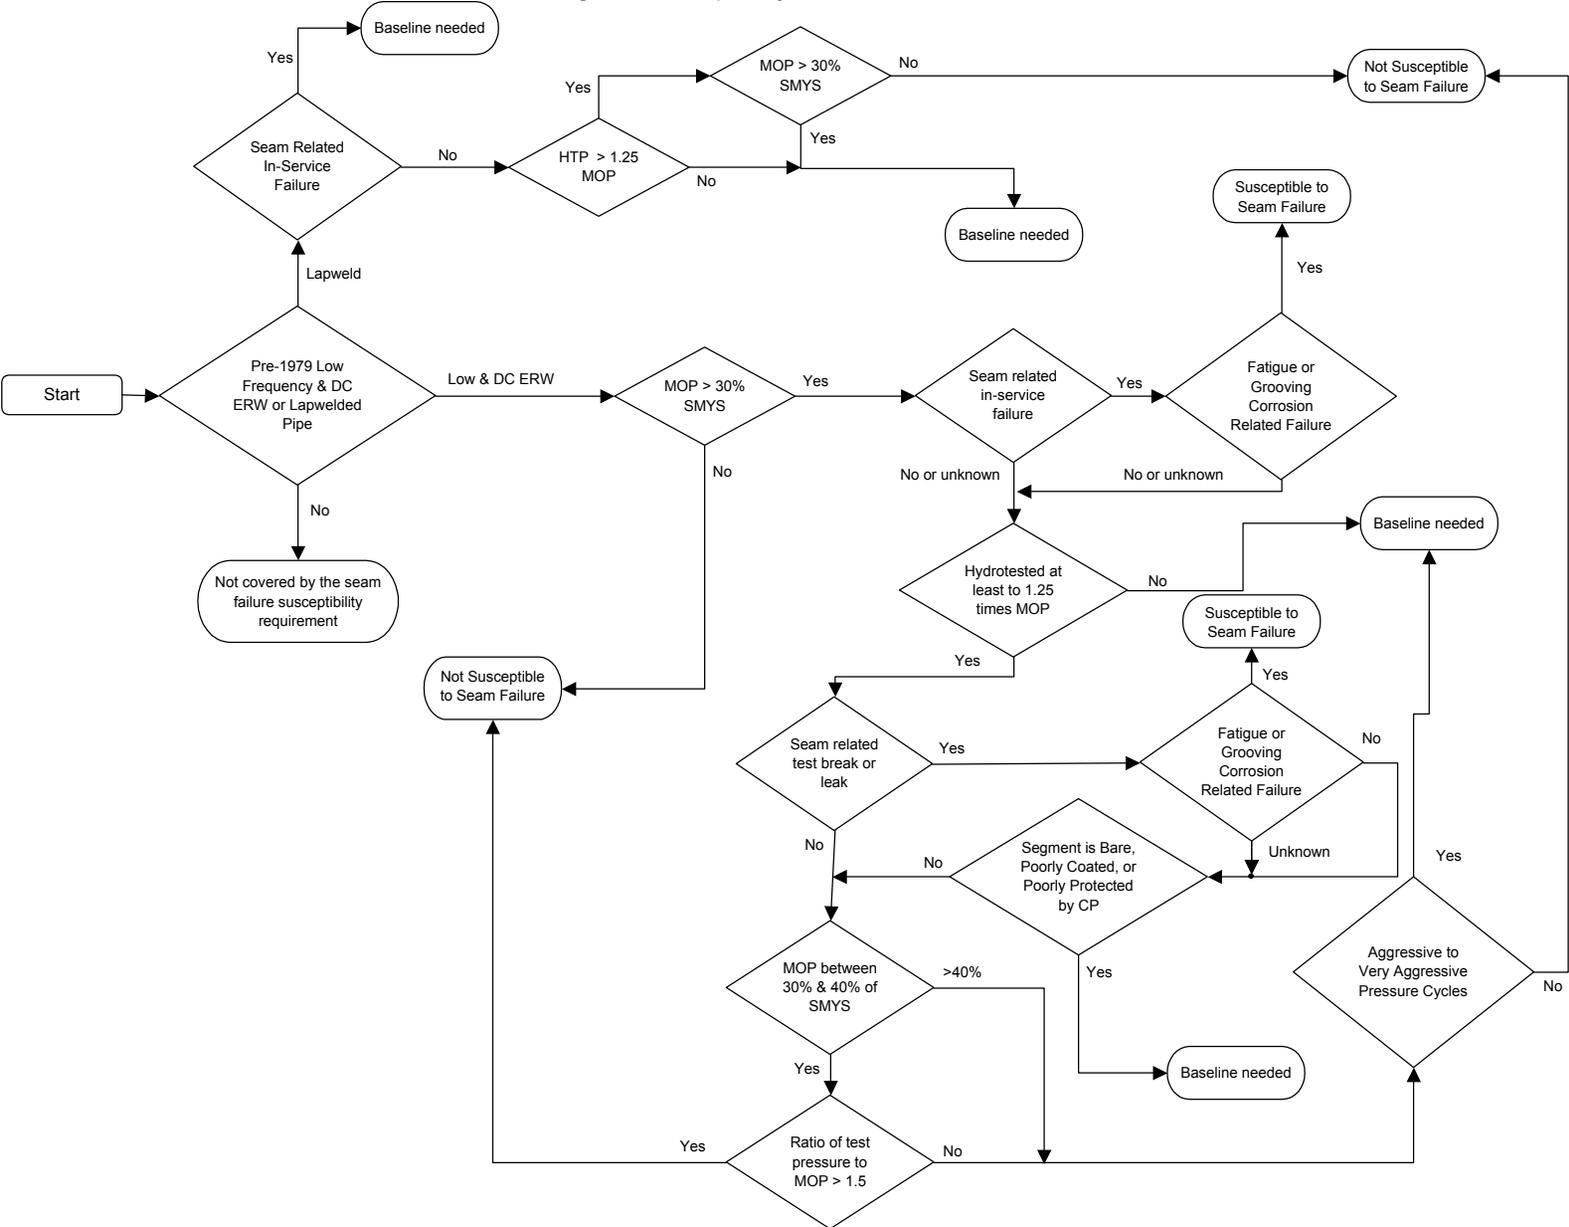
### Long Seam Susceptibility Criteria For Baseline Assessment

The roles that those parameters play in the determination of the need for integrity assessment are discussed below roughly in order of their importance. An example of a decision-making format for determining whether or not an ERW seam-integrity assessment plan is necessary is shown in Figure 1. Because it can be anticipated that an operator's plan for integrity assessments of ERW pipe will be audited by the Office of Pipeline Safety and/or state regulators, the plan should include every ERW or flash-welded segment affecting an HCA. In many cases, it may be sufficient to note that the segment was considered but eliminated with no need for further analysis because

The new regulations, Part 195 Section 195.452, require that special integrity assessments be made to address potential seam-defect problems in low-frequency-welded ERW (electric-resistance-welded) pipe materials where a failure of such materials could have an impact on a high-consequence area (HCA). The spirit of this requirement appears to require action if, and only if, significant seam-related deficiencies are in evidence or if they can be reasonably anticipated. This leaves open the option of categorizing these types of pipelines by performance such that potentially problematic pipeline segments can be subjected to special (i.e., seam-quality) inspections while those that show little or no propensity for such problems can be subjected to metal loss and deformation inspections only. This document is intended to establish a systematic procedure to permit an operator to characterize the relevant ERW pipe segments as to the likelihood of significant seam-related deficiencies. The author is particularly grateful to Rich Turley of Marathon Ashland Pipe Line LLC for helping to formulate the essential steps in deciding when an integrity assessment is needed. Rich made significant inputs to Figure 1 of this document.
